CENTRAL INTELLIGENCE AGENCY

COUNTRY	East Germany	REPORT	
SUBJECT	Gross Doelln Airfield	DATE DISTR.	14 December 1955 50X1-HUM
		NO. OF PAGES	3
DATE OF INFO.		REQUIREMENT NO.	RD
PLACE ACQUIRED		REFERENCES	50X1-HUM
DATE ACQUIRED

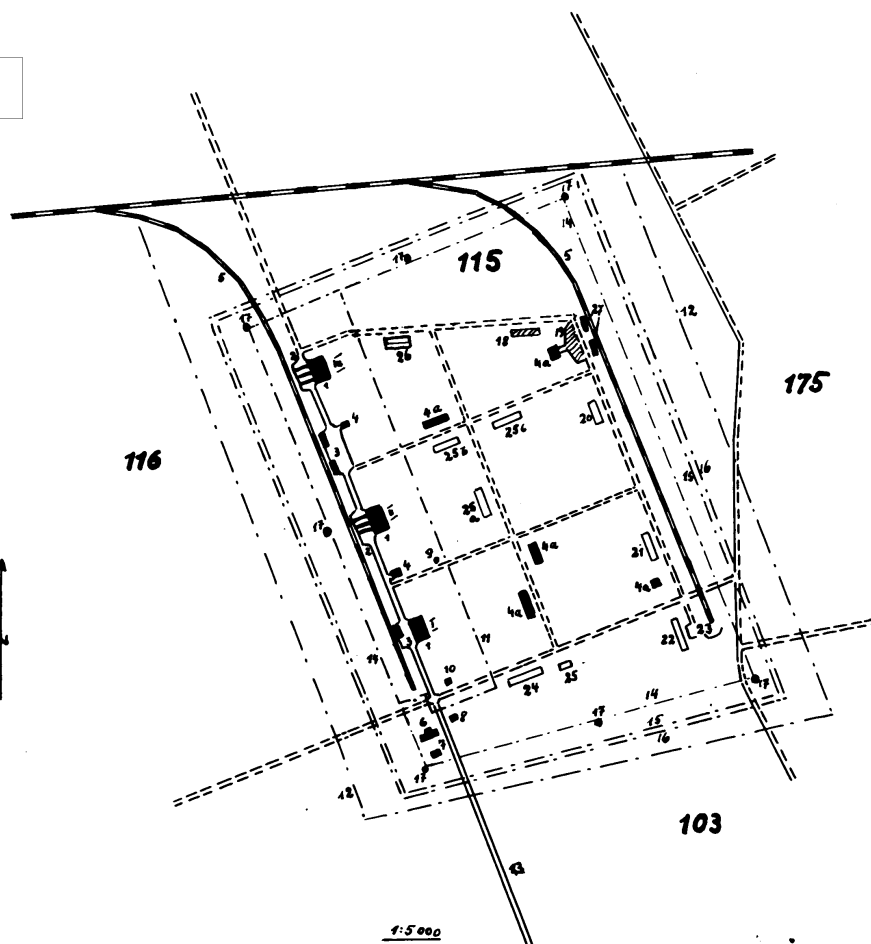
Appendix "A"

7. Ammunition Dump
 - a. Additions have been made to the ammunition dump. At the present (see Attachment A) the main effort is concentrated on the security of the dump and changes are under way. The old fence is being demolished and the material being used for new fencing. A belt, approximately 50 m. wide, around the old fence boundary is being cleared of trees and levelled. There will be 3 new fences:

Point 14, Attachment A, is partly an extension of the interior fencing of the dump.
Point 15, Attachment A, is approximately 20 m. from the first fence.
Point 16, Attachment A, is approximately three meters distant from the second fence and with it forms a corridor which later will be patrolled by dogs.
 - b. Between the first and second fence, approximately two meters from the first, seven wooden watch towers have been constructed (Point 17, Attachment A).
 - c. As a further security measure 120 lights on masts are being erected within the fencing so that they illuminate the 50 m. wide belt beyond the third fence but leave the watchtowers and guards in darkness.
 8. Transformer Stations
Six new transformer stations have been constructed at the following locations:

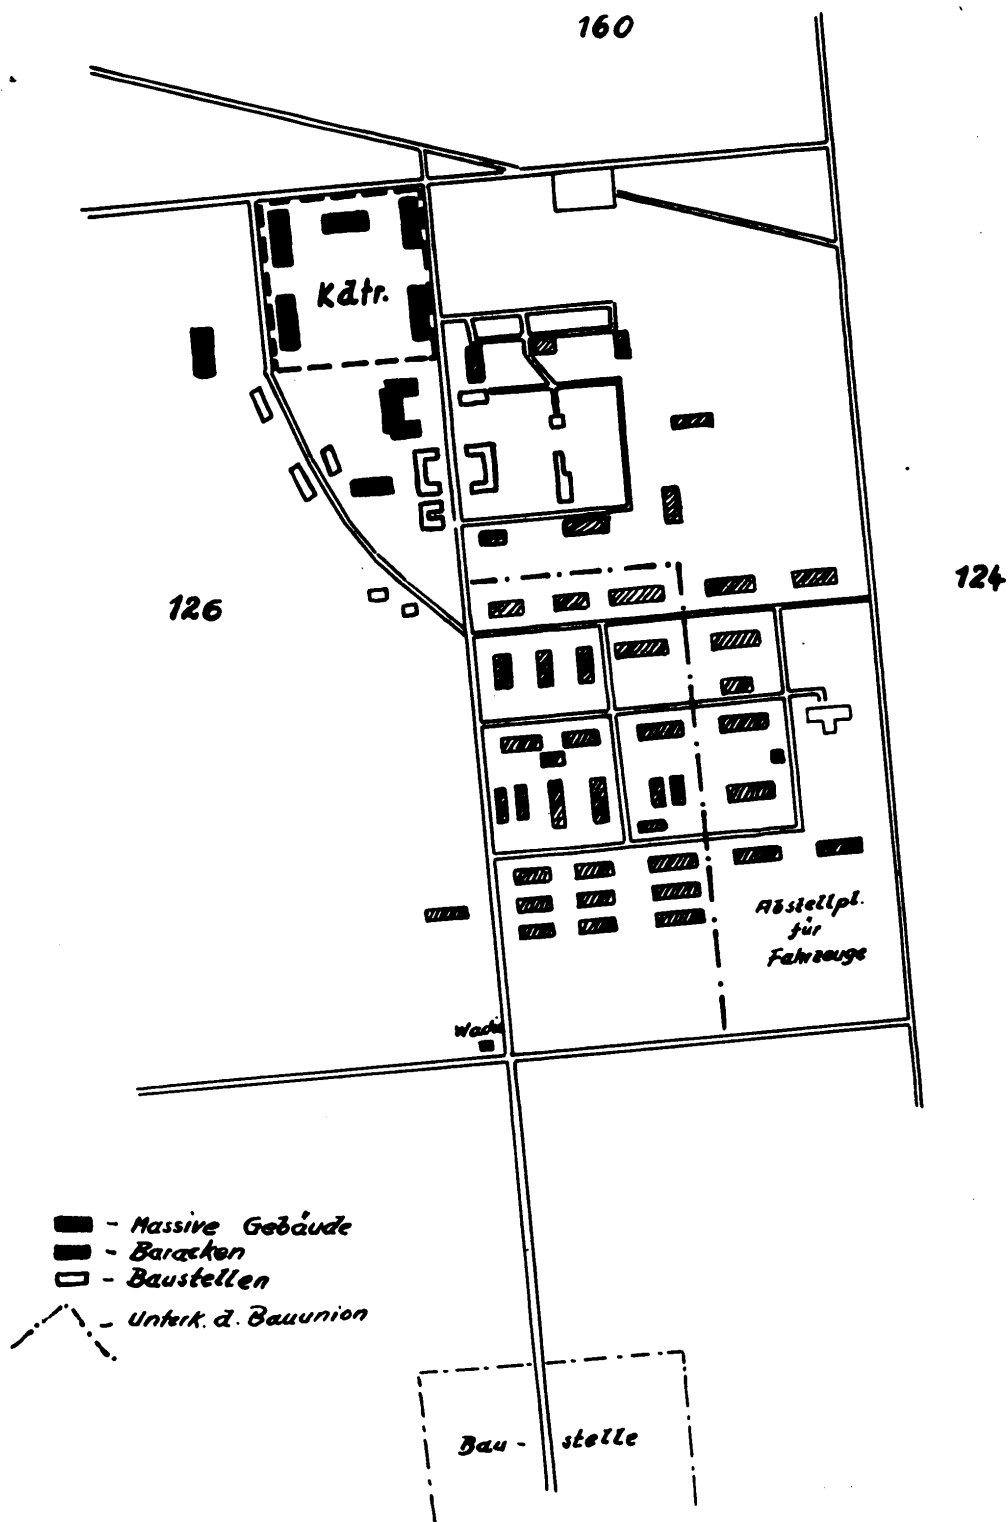
Appendix "B"

- 1. Sketch of ammunition dump area.
- 2. Plan of barracks construction project
